SOLDERING INDUCED DAMAGE TO THIN SI SOLAR CELLS AND DETECTION OF CRACKED CELLS IN MODULES

Andrew M. Gabor, Mike Ralli, Shaun Montminy, Luis Alegria, Chris Bordonaro, Joe Woods, Larry Felton
Evergreen Solar, Inc.

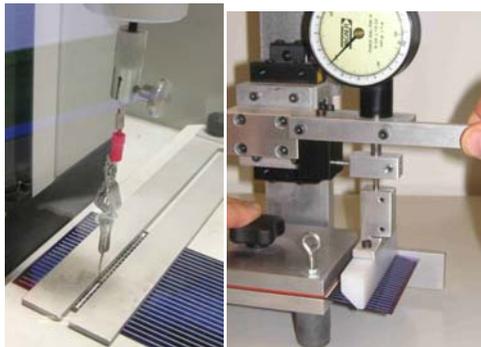
Figure 1: Wire pull strength and Cell breakage strength tests

Since it was not obvious to us or others that higher pull strengths were better for either crack minimization or long term module reliability [2], and since microscopy also did not lend itself toward quick or easily quantifiable feedback, we developed a new measurement which would better correlate with the soldering damage. Figure 1 shows a breakage strength tester which clamps the cell behind the busbar region and then applies a downward force to the region of unsupported cell. The maximum downward force achieved prior to cell breakage is recorded. In particular we concentrated on the metric of the % of weak cells from the testing where the cell broke with minimal force (gauge reading <75g). We found that this data correlated well with the mechanical yield of the process and in many cases correlated to the number of

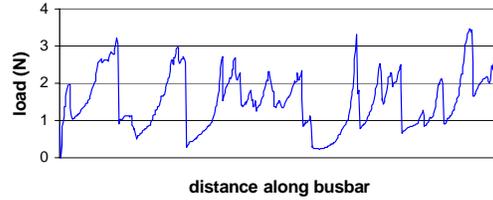
Figure 2: Wire pull strength data

Figure 2 shows an example of pull strength data. The peak force can be misleading since the average value can be much lower. We used the area under the curve instead. We found weak correlation between the pull strength values and the number of cracked cells found in the modules. Also, the desired interface was not obvious.

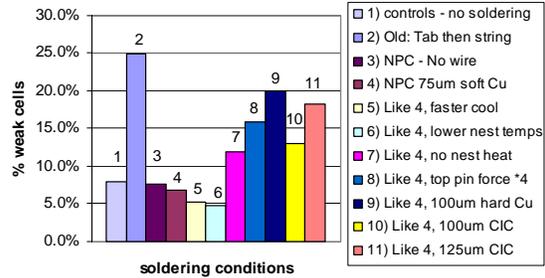
Figure 3: Cell breakage strength data

In one experiment we randomized a large group of cells made from 190-micron thick String Ribbon Si wafers into 11 groups of 26 cells each. Most of the groups were then soldered under different conditions, followed by wire pull tests for 3 cells (2 wires/cell) and breakage strength tests for the remaining cells (2 tests/cell). The results are summarized in Figure 3 and discussed in the sections below.

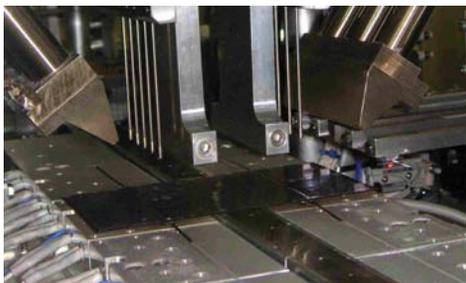
Figure 4: NPC tabber-stringer

Most of the groups were soldered using a commercial combined tabber-stringer built by NPC which uses hot air to reflow the solder and pins to press the wires against the cell on both the top and bottom side (see Figure 4). In contrast to our old sequential soldering machines whereby wires were first tabbed to the front busbar with hot air then cells were strung together on the back side in a second heating step, the NPC machine reduced the % of weak cells by a factor of 3. Indeed, the % of weak cells was not much different from the % found for the controls prior to soldering or to cells which went through the machine with no wire. Thus the machine under optimized conditions and materials did minimal damage to the cells, and some cells were found to be already weak due to upstream processing.

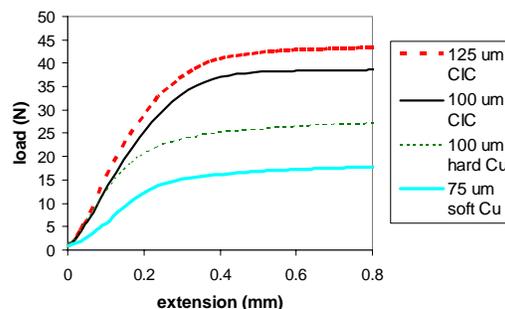
Figure 5: Instron load-extension curves for 4 different wires

The reduction in breakage strength is consistent with the tensile load-extension curves for the wires. This data was collected on a commercial stress-strain system from Instron and is shown in Figure 5. The inflection points of the curves show the thicker wires to yield at higher loads. We conclude from the data that when soldering with the 75-micron Cu wire, damage to the silicon is minimized due to the greater compliance of the thinner and softer wire such that the Cu yields during the cooldown below the solder melting point. The lower modulus may also play a role. Harder and thicker wires are unable to yield as much and thus stress the silicon more and cause microcracks. This yielding appears to be a more important factor for the strength of the cells as measured by our breakage strength tester than the reduction in the effective CTE of the wire by the Invar. All curves were taken using wire samples directly from the spools. In practice, the wire is straightened by the soldering equipment to remove coil-set and camber, and our Instron tests showed these operations to work harden the wires a small amount. Care should be taken to cold-work the wire no more than is necessary to obtain good alignment and machine operation.

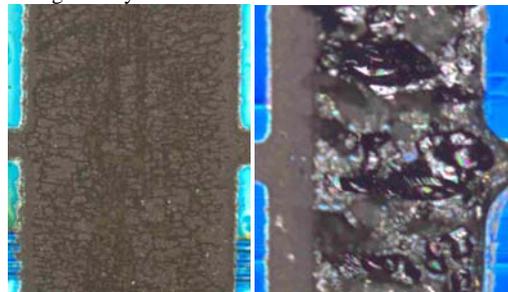
Figure 6: Wire-pull failure interfaces for paste A (left) and paste B (right).

In addition to the soldering process, equipment, and materials variables, we found that the cell metallization process and materials also affected the soldering results. The choice of Ag paste appears to have a strong impact on the wire pull test results. Figure 6 shows an optical microscope image of a typical wire-pull failure interface for cells from condition #4 in the above experiment using Ag paste A. The failure occurs cohesively within the fired Ag busbar metallization. When using a different commercial front Ag paste (paste B), perhaps with more aggressive glass frit or different Ag particle sizes, the failure interface is typically within the Si, likely indicating some damage to the Si matrix that existed prior to soldering. In this latter case, the breakage strengths and wire pull strengths are also significantly lower. Thus, in order to optimize yields and reliability, it may be important to optimize the metallization process not only for cell efficiency, but also for mechanical strength and yield.

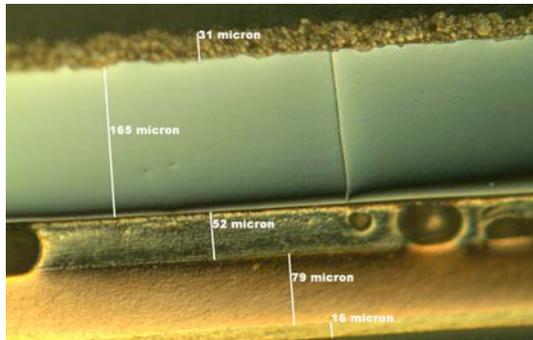
Figure 8: Optical cross section image showing a vertical crack through the Si extending along the length of the front wire

A cell soldered using paste B was epoxy-potted, sawn along the length of the wire, then polished for cross-section SEM analysis. The image in Figure 7 shows a crack roughly parallel to the top face of the cell. This crack face is consistent with the wire pull failure interface seen where the wire easily pulls up chunks of Si. Vertical cracks are also seen in polished cross-

sections such as the one in the optical microscopy image in Figure 8. However, using cross section microscopy to hunt for and count cracks is time consuming and offers poor statistics.

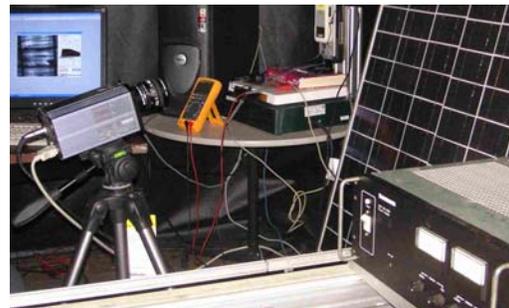
Figure 9: Electroluminescence Crack Detection (ELCD)

The second technique was inspired by the photographic surveying technique described by Fuyuki [4], but uses different equipment and focuses on crack detection instead of diffusion lengths. Recent work by Trupke [5] and Takahashi [6] describes this Electroluminescence (EL) technique in more detail for mapping cell quality. Our Electroluminescence Crack Detection (ELCD) system, shown in Figure 9, comprises a digital monochrome camera (Photometrics Cascade 512b) equipped with a filter to block out visible light. We found that by forward biasing the modules in a dark room at a current about 1 to 1.5 times that of the I_{sc} rating of the module, the cells emit enough light with

wavelengths $< 1140\text{nm}$ to give a clear image with the camera and the time averaging software. In the ELCD technique, if a crack partially or fully separates a region of the cell from the wires, then this region appears darker. If a crack separates the cell into two unequal regions that each contact a wire, then the larger region appears darker than the smaller region. In general cracks are visible as dark lines, but care must be taken in interpreting images of multicrystalline material since grain boundaries, low lifetime regions, and printing defects also correspond to darker regions. Although we have largely applied the technique to modules, it also works at the unencapsulated string or cell level for crack detection.

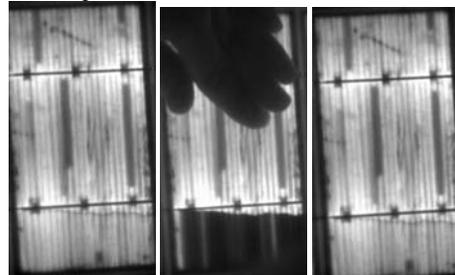
Figure 10: ELCD images before, during, and after pressing on a module above a cracked String Ribbon cell

Figure 10 shows ELCD images of a typical cracked cell in a module. The image on the left shows the cell with no pressure applied to the module, and the crack line can be seen below the bottom busbar. By pressing hard on the module to flex it, the crack is opened up, interrupting the continuity of current flow across the metallization pattern. This electrically isolated bottom portion of the cell is thus largely seen as dark in the middle image. After removing pressure from the module surface, the crack closes again, and apparently continuity of the metallization pattern is retained across the crack as can be seen in the rightmost image. Other dark rectangular regions in the images correspond to regions where the front Ag grid had printing defects (not visible by eye) that interrupted continuity. Other cell imaging methods that operate at short circuit conditions cannot detect such problems.

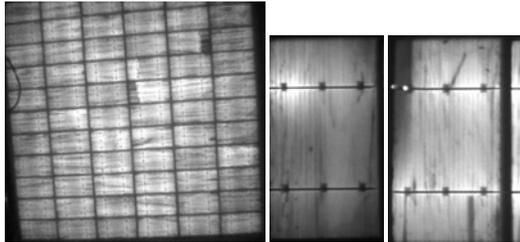
Figure 11: ELCD images of (left) part of a load-tested module with 3 cracked cells, (middle) a cell with only 1 connected rear solder pad, and (right) of a cell with the wire pulled off 1 cm of the top left busbar region

By changing the camera lens and increasing the camera to module distance, more of the module can be imaged as is shown in Figure 11 for a load tested module with 3 cracked cells. The system could also be used to examine potential soldering-related reliability problems where wires and underlying metallization are somehow torn from the Si surface. Figure 11 shows an

unencapsulated cell where the wires were manually pulled off from 5 of the 6 rear solder pads, leaving a signature of a brighter region around the last remaining pad. Also shown is a cell where one of the front wires was pulled up for 1 cm, leave a signature of a dark region where the front grid is isolated, and a gradient in the brightness away from the remaining busbar. Finally the system can also be used to inspect the quality of the cell binning [7]. Certain cells within a string sometimes appear overall darker or brighter than the surrounding cells. This may indicate electrical mismatch in the cell current-voltage characteristics such that at the applied current, different cells are operating at significantly different voltages.

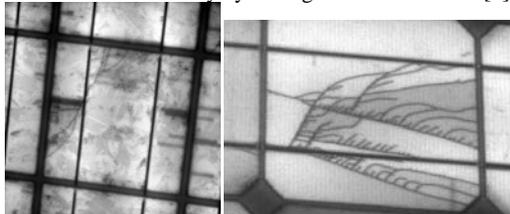
Figure 12: ELCD images of cracked multicrystalline and single crystalline cells

Modules from 4 different large PV manufacturers were also analyzed by ELCD both before and after load testing. A significant percentage of cells were found to contain cracks after the load testing in all cases, both for single and multi-crystalline cells. In all cases, the power degradation after load testing was below 2% or within the uncertainty of the flash IV test system. Although some cracked regions appear slightly darker, such as in the rather interesting region of the single-crystal cell in Figure 12, the great majority of cracked cells appear to have fully active area, indicating the robustness of the design. It is unclear, however, whether thermal cycling and other field exposure over many years would cause opening of tightly closed cracks and thus cause further unacceptable power degradation. Such concerns have been discussed recently by Wohlgemuth at BP Solar [8].

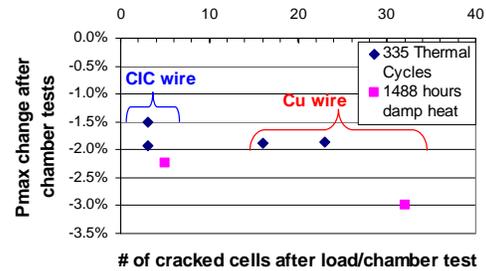
Figure 13: Module power degradation from environmental chamber testing

To address these module reliability issues we performed environmental chamber tests. We made six 108-cell modules with 2 of the interconnect wires described above in section 2: the standard 75 micron soft Cu wire and the 100 micron Cu/Invar/Cu wire (CIC). We applied loads with bricks sufficient to crack several cells in the Cu wire modules. The same load cracked very few cells in the modules with CIC wire. However, as is

shown in Figure 13, even after chamber exposure well beyond the IEC-dictated 200 thermal cycles and 1000 hours damp heat, the power degradation is minimal for both cases and no convincing advantage is seen for the CIC-wire modules.

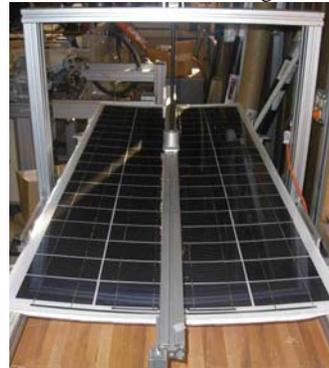
Figure 14: Laminate flex tester

To better understand the crack formation process in the module, we built a system to perform controlled deflection of unframed laminates by applying line pressure in the center as is shown in Figure 14.

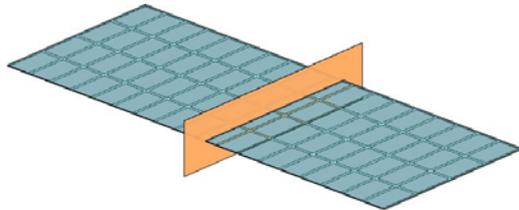
Figure 15: FEA model of the laminate

We performed analytical modeling and Finite Element Analysis to help understand the root causes of these observations. The model structure is shown in Figure 15. In particular, the analysis allowed us to:

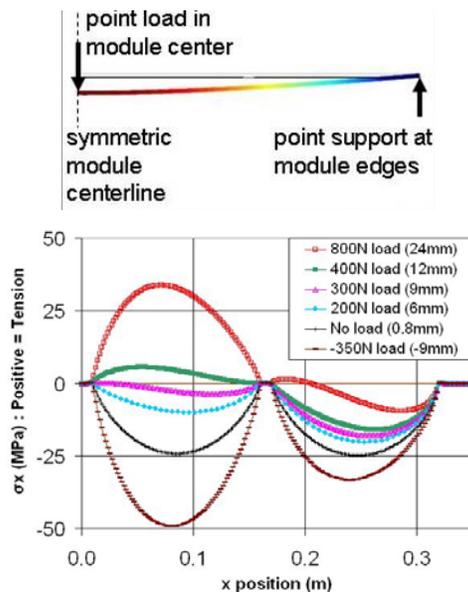
Figure 16: FEA results across the length of 2 cells in the middle and outer strings of bent laminates

A significant finding of this analysis (see Figure 16) was that the cells are in compression after cooling from

the lamination step, but that applying a load to the glass side of the laminate can put the cells into tension (where the cells in the center strings of the module go into tension first). Certain pre-existing micro-cracks in the cells due to damage from soldering or cell fabrication processes will have a tendency to open up further and propagate into full length cracks under this tensile stress state. Conversely, applying pressure to the backskin side of the module puts the cells into a higher compressive state, thus pushing microcracks closed tighter, and this explains the lack of cracking seen by loading the back side.
